CASE STUDY:

City of Durham Fire Station #1

LOCATION: DURHAM, NC

Concrete Repairs and Restoration

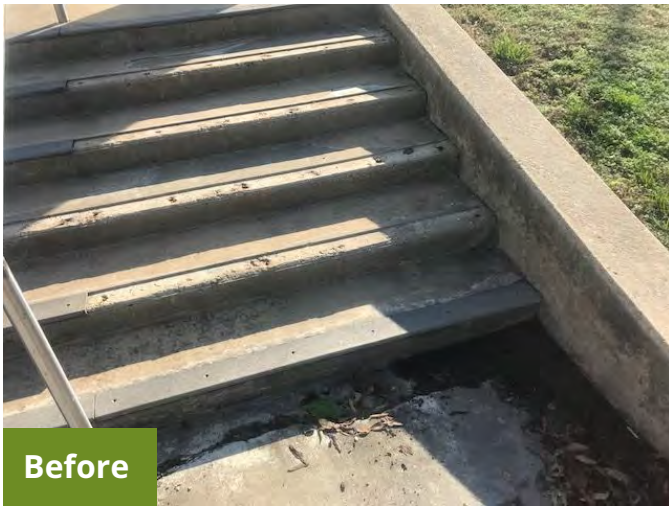
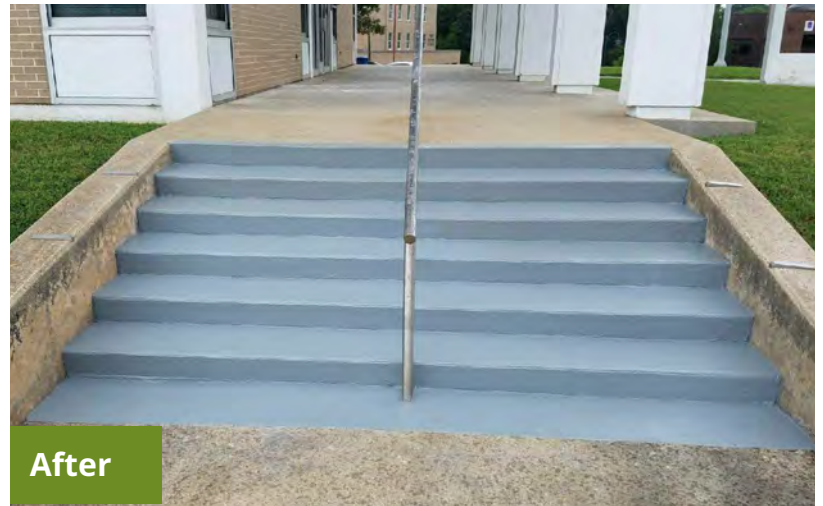
Two sets of concrete steps outside the City of Durham's Fire Station #1 were significantly deteriorated and were ponding water and ice, causing slip and trip hazards. The concrete was cracked, chunks of concrete were broken and/or missing and the treads were separating from the steps. Tearing out and replacing the steps would be costly, disruptive and time-consuming.

Simon Surfaces first removed the remaining treads and filled in the areas with its self-manufactured epoxy mortar, which was also used to repair the areas of broken/missing concrete. The ponding areas received additional material to create a slope to drain water and eliminate ponding. They filled the cracks with SR Polyurea, a flexible epoxy material. Finally, the stairs were coated with two layers of epoxy and slip-resistant material was applied to the entire stairway. The entire process took just two days to complete and the stairs could experience foot traffic after 24 hours. A concrete tear-out and replacement would have taken up to a week from start to finish, and would have had a 14-21 day cure time following completion.

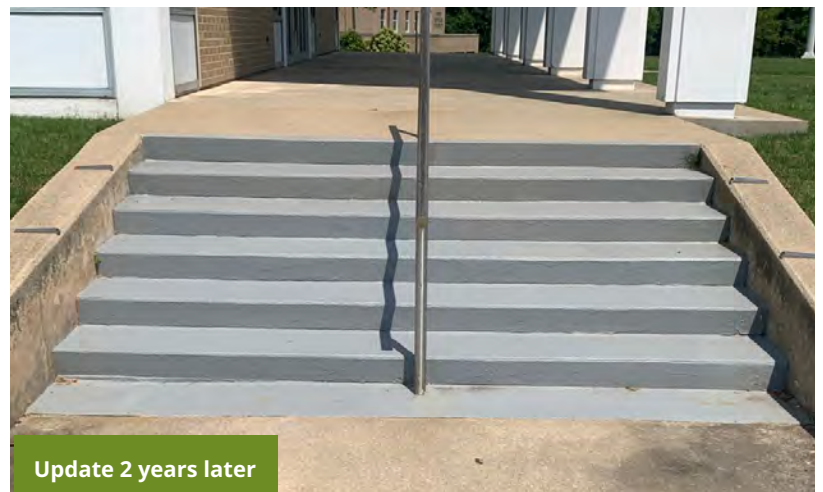
Two years after the restoration, Simon Surfaces returned for an inspection and the steps were still in great condition.
