CASE STUDY:

Home Improvement Store

LOCATION: SPRINGFIELD, OH

Concrete Repairs + Simon HD

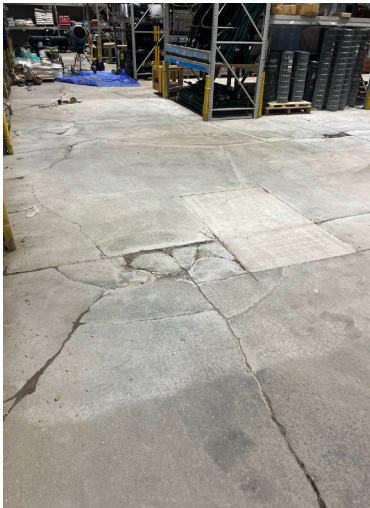
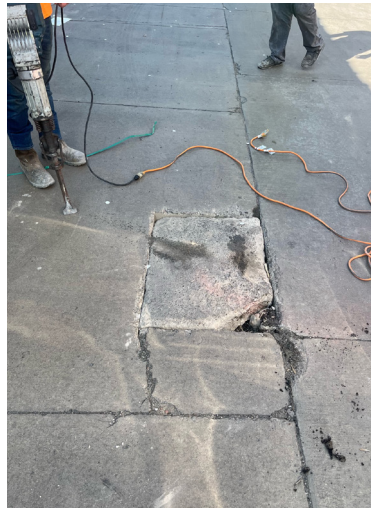
Before

There were several parts of the large home improvement retail store – including both indoor and outdoor storage and shopping areas – that had deteriorated concrete consisting of cracks, spalling, and more. Plus, the entrance to the store was unlevel and was cracked, which was causing shoppers' carts to get stuck as well as posing a safety hazard. The surfaces of the shopping areas had cracks and concrete damage throughout, which were causing trip hazards for both employees and customers. The floor of the storage area had been repaired multiple times and the entire area was failing.

Simon Surfaces performed both concrete repairs and concrete restoration across the various surfaces, depending on need. All cracks were filled in throughout all floors, including the interior storage areas and exterior garden center shopping areas. The concrete entrance was completely restored using Simon HD to eliminate all of the bumps and cracks causing safety concerns. The storage area floor was also restored with Simon HD due to the extent of the damage from numerous previous repairs.
